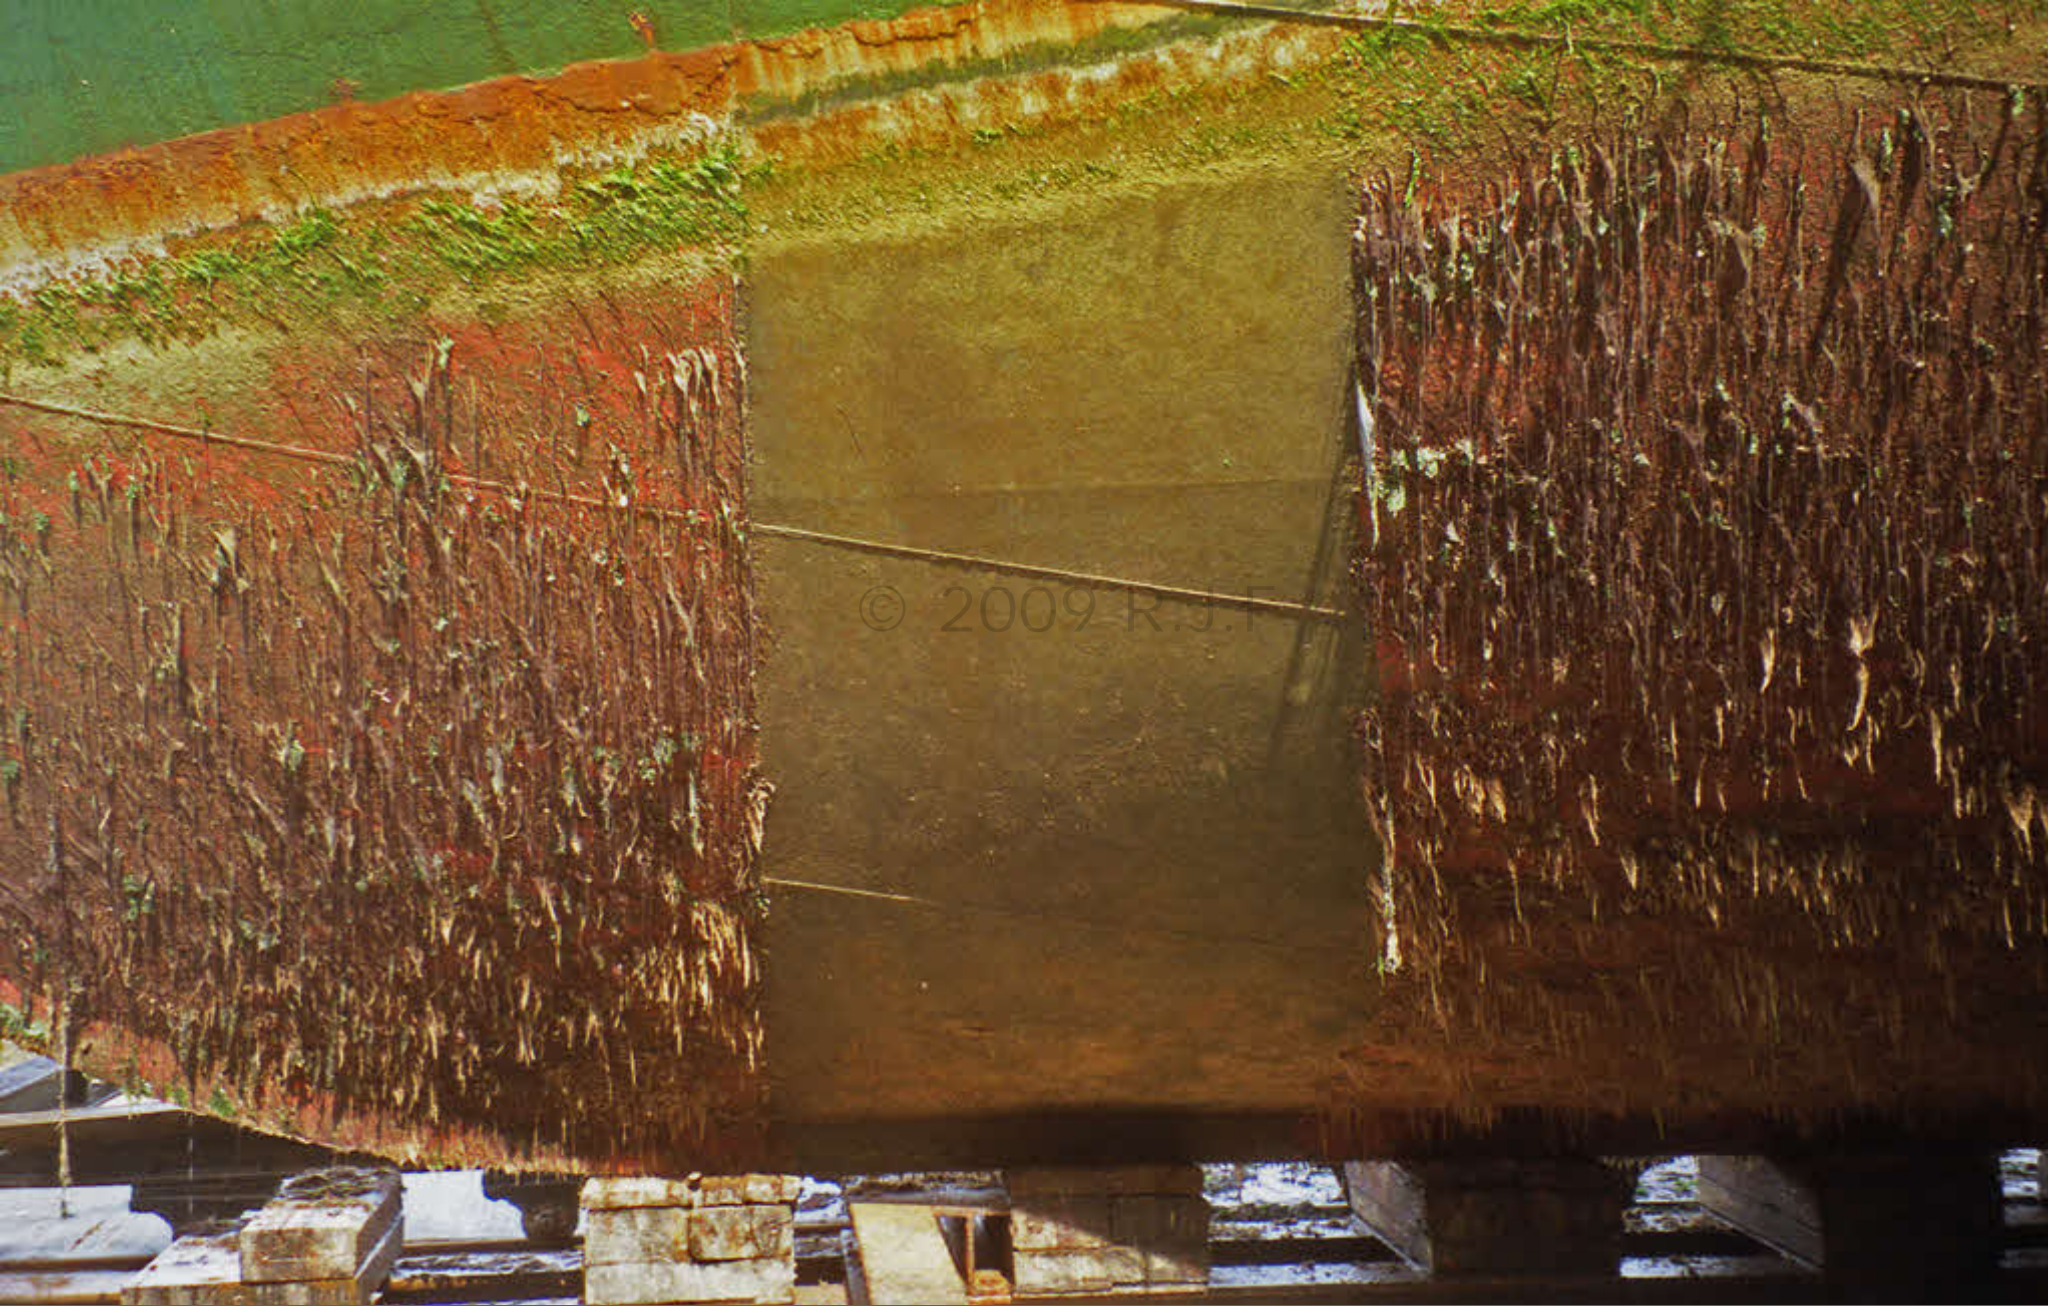
This picture shows a trial patch of Copperplus that was applied to a tug that was moored in Fowey harbour for two years. When slipped the Copperplus was virtually clean while the remainder of the vessel has a thick covering of growth of all types. The remainder of the vessel has been coated with a well known brand of commercial antifouling.
