# Gelshield Plus Application Manual

## **Osmosis, Gelshield Plus and Associated Products**

# Understanding and Assessing Osmosis

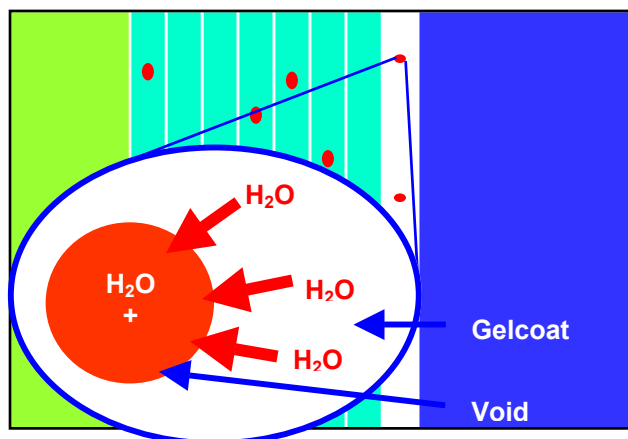
### Stage 2 – Solutions form in Voids

Initially in the Gelcoat, where the moisture content is higher. And then deeper in the laminate as the condition progresses.

The moisture present starts to break the resin down by hydrolysis.

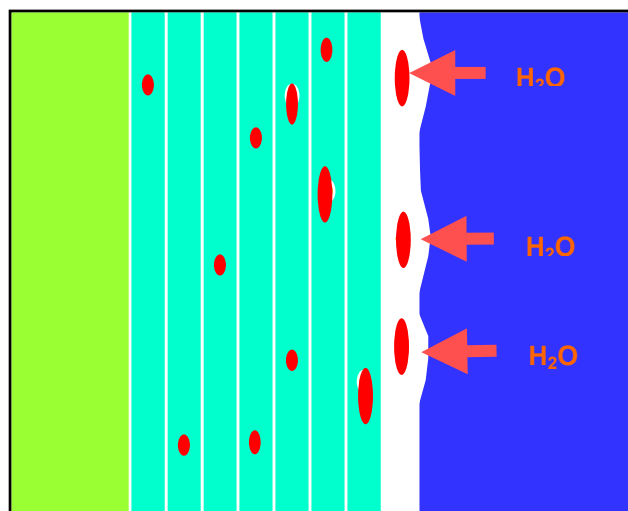
### Stage 3 – Blister Formation

The concentration cells formed draw in more moisture that causes blisters to form and swell.

The increased pressure also tends to accelerate the breakdown of the laminate resin.

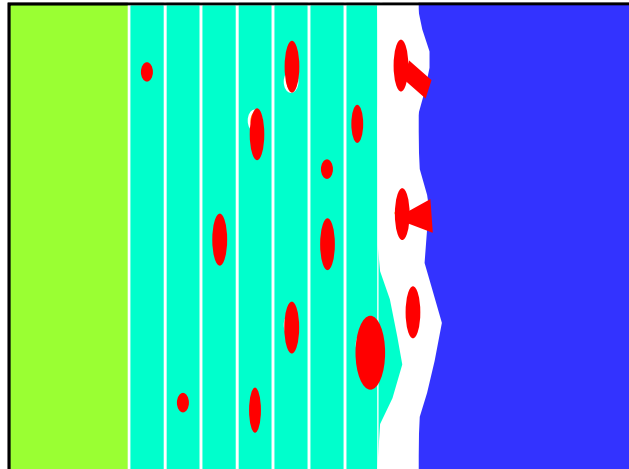
#### Stage 4 – Laminate Failure

Continuing resin breakdown and increasing pressure in blisters leads to some blisters bursting.

Deeper in the laminate, large blisters cause laminate breakdown and eventual failure.

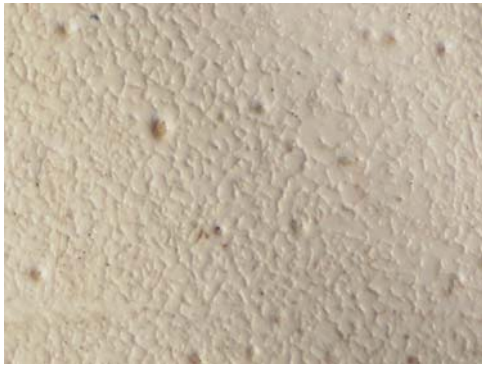
**Pinholes.** Small pinhead-sized bubbles in the gelcoat that will either have burst or shown up as little voids. This indicates that the effective gelcoat thickness is much less than it should be below the waterline. In turn, this will allow water to penetrate the hull more easily; the thinner the gelcoat the quicker water will be absorbed.

Surface of GRP laminate magnified 32x showing pinholes in the pigmented surface

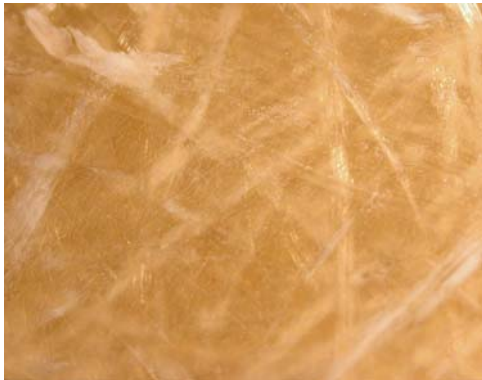
**Prominent fibres.** These can sometimes be seen protruding either beneath or through the gelcoat. This allows 'wicking' to occur, this being defined as the process by which water is drawn into the hull by capillary action.

Surface of a GRP laminate showing prominent fibre magnified 32x

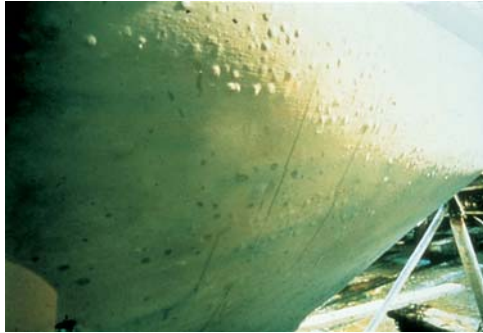
**Blisters. These normally occur only below the waterline and are usually evidenced as bubbling of the antifouling. In this eventuality the antifouling will need to be removed to enable the underlying cause of the problem to be ascertained.**

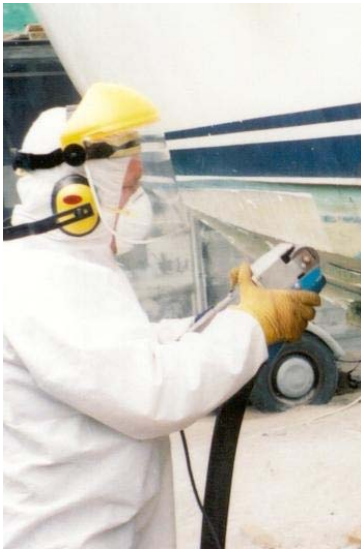
- **Gelcoat Peelers:**

In recent years this has become the most popular way of removing antifouling coatings and blistered gelcoat. The two invariably go together with the antifouling, however long in service, presenting a toxic hazard. Gelcoat Peelers have the advantage of removing both substances into containers without a toxic hazard whilst at the same time retaining the contour of the hull.

Care should be taken in setting the blades on the power plane to a suitable depth for removal. It is advisable after peeling to lightly grit sweep or grind the surface to expose any deep-seated voids and to give a sound mechanical key.

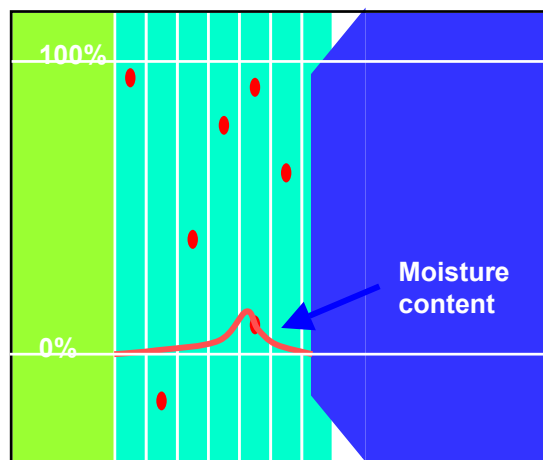
The purpose of this test is to see if there is moisture deeper in the laminate that may not be revealed by the meter test. As shown in the diagram, moisture quickly evaporates from the surface whilst remaining deeper in the laminate. This situation can also develop if the solutes and impurities are only washed out of the outer layers of laminate. In this instance it may be necessary to remove more layers of laminate.

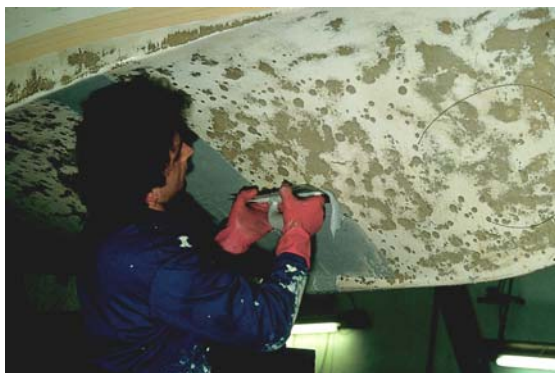
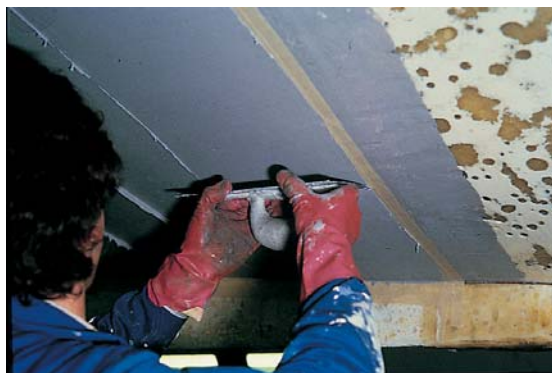
Filling should be undertaken with **Interfill 830 Epoxy Profiling Filler (YAA867/YAA868)**, which is also a solvent free material. This filler has been formulated for application over large areas in a thickness of up to 2cm. It can be applied using a plaster trowel and screeded off with a batten. When applying the filler, care should be taken to ensure that it is worked thoroughly into all indentations and crevices. It is essential that no voids are allowed to remain. The ideal, experienced operator should be able to achieve a 95% smooth surface at the first attempt. Do not apply a thicker coating of filler than is strictly necessary.

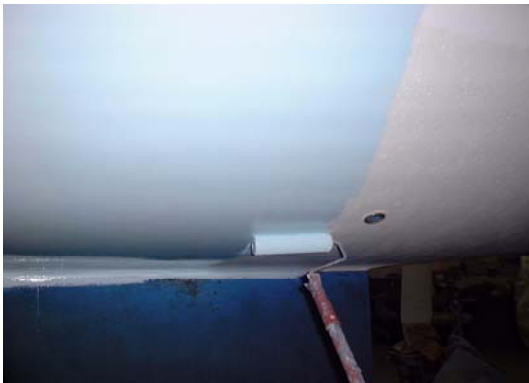
Gelshield Plus blue: roller application

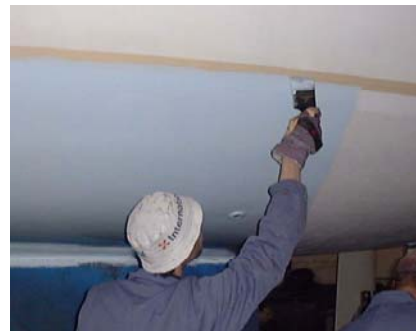
Gelshield Plus blue : tip-off by brush

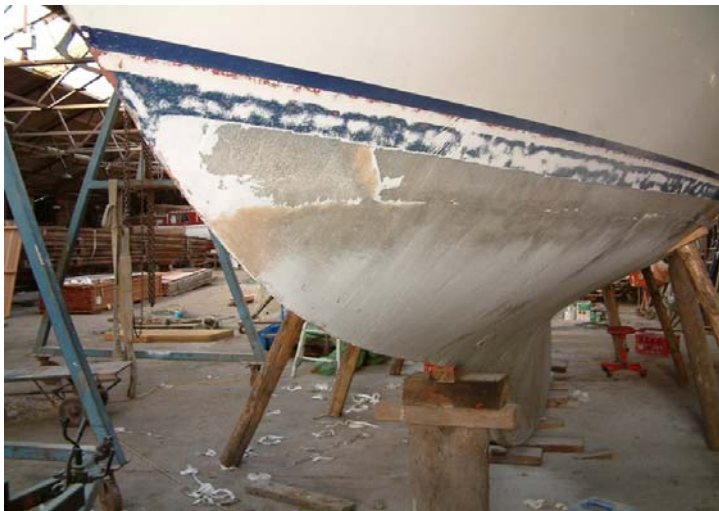
**An epoxy coating system is a very effective moisture barrier, however this also applies to impurities in the laminate not removed as part of the preparation regime. Once the yacht is back in service, moisture re-entering the hull, normally via the bilges may react with these forming compounds that cannot pass through the epoxy barrier. Blistering between coating and the hull may be the result of this action.**
